## BELZONA RECLAIMS AND PROTECTS SULFURIC ACID BUND

Sulfuric Acid Refinery - Wyoming U.S.A.

850 sq.ft. secondary containment area for 98% Sulfuric acid.

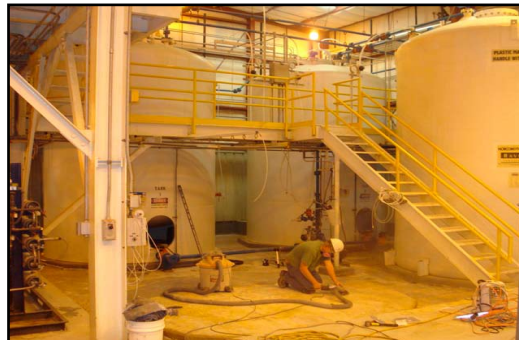
1. Overview of the acid containment area
2. View of the damaged concrete
3. View of area rebuilt and resurfaced
4. Completed job after coating with Belzona® 4311

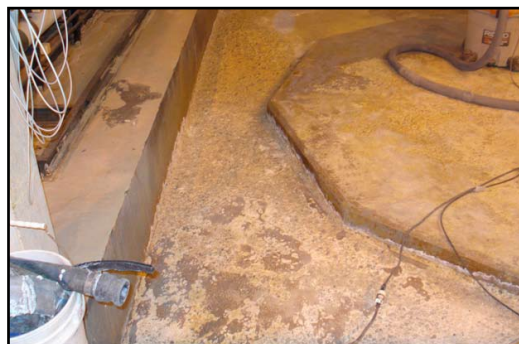
Previous product used gave limited results. Extensive rebuilding of the concrete was needed to allow the containment area to drain to the center sump, to be followed by a protective coating.

Application was carried out in accordance with Belzona Know-How System Leaflet TCC-9 and 15. Concrete was rebuilt to create falls to central sump. Entire area then protected with Belzona® 4311.
