Belzona[®] Protects Slug Catchers Against Erosion and Corrosion

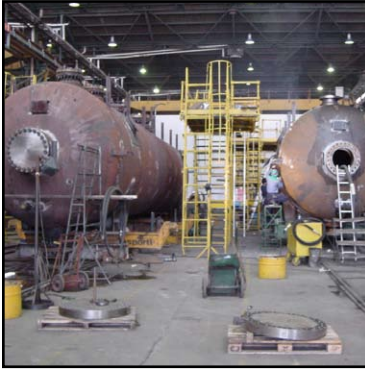
Two of the slug catchers ready for internal coating.

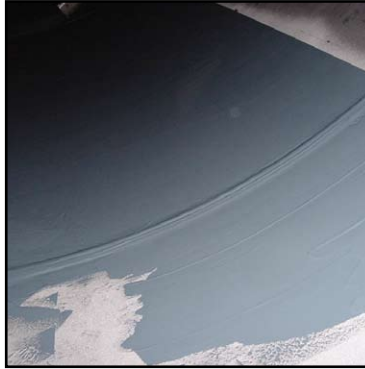
The Belzona[®] 1391 being applied.

Application was carried out in accordance with Belzona Know-How System Leaflet TCC-3. Particular care was taken to maintain temperature of the substrate during application.

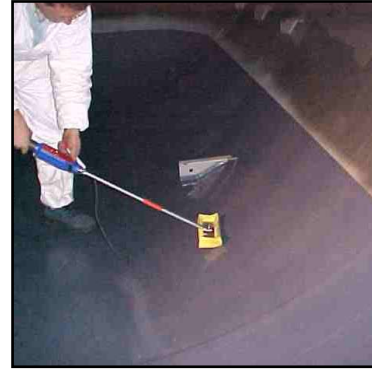
Sponge testing the Belzona[®] 1391 to ensure no application defects were present in the coating.
